REPORT OF INVESTIGATION  
(Underground Coal Mine)

NONINJURY COAL MINE OUTBURST (BOUNCE) ACCIDENT

L. S. Wood Mine (ID No. 05-00300)  
Mid-Continent Resources, Inc.  
Redstone, Pitkin County, Colorado

July 1, 1980

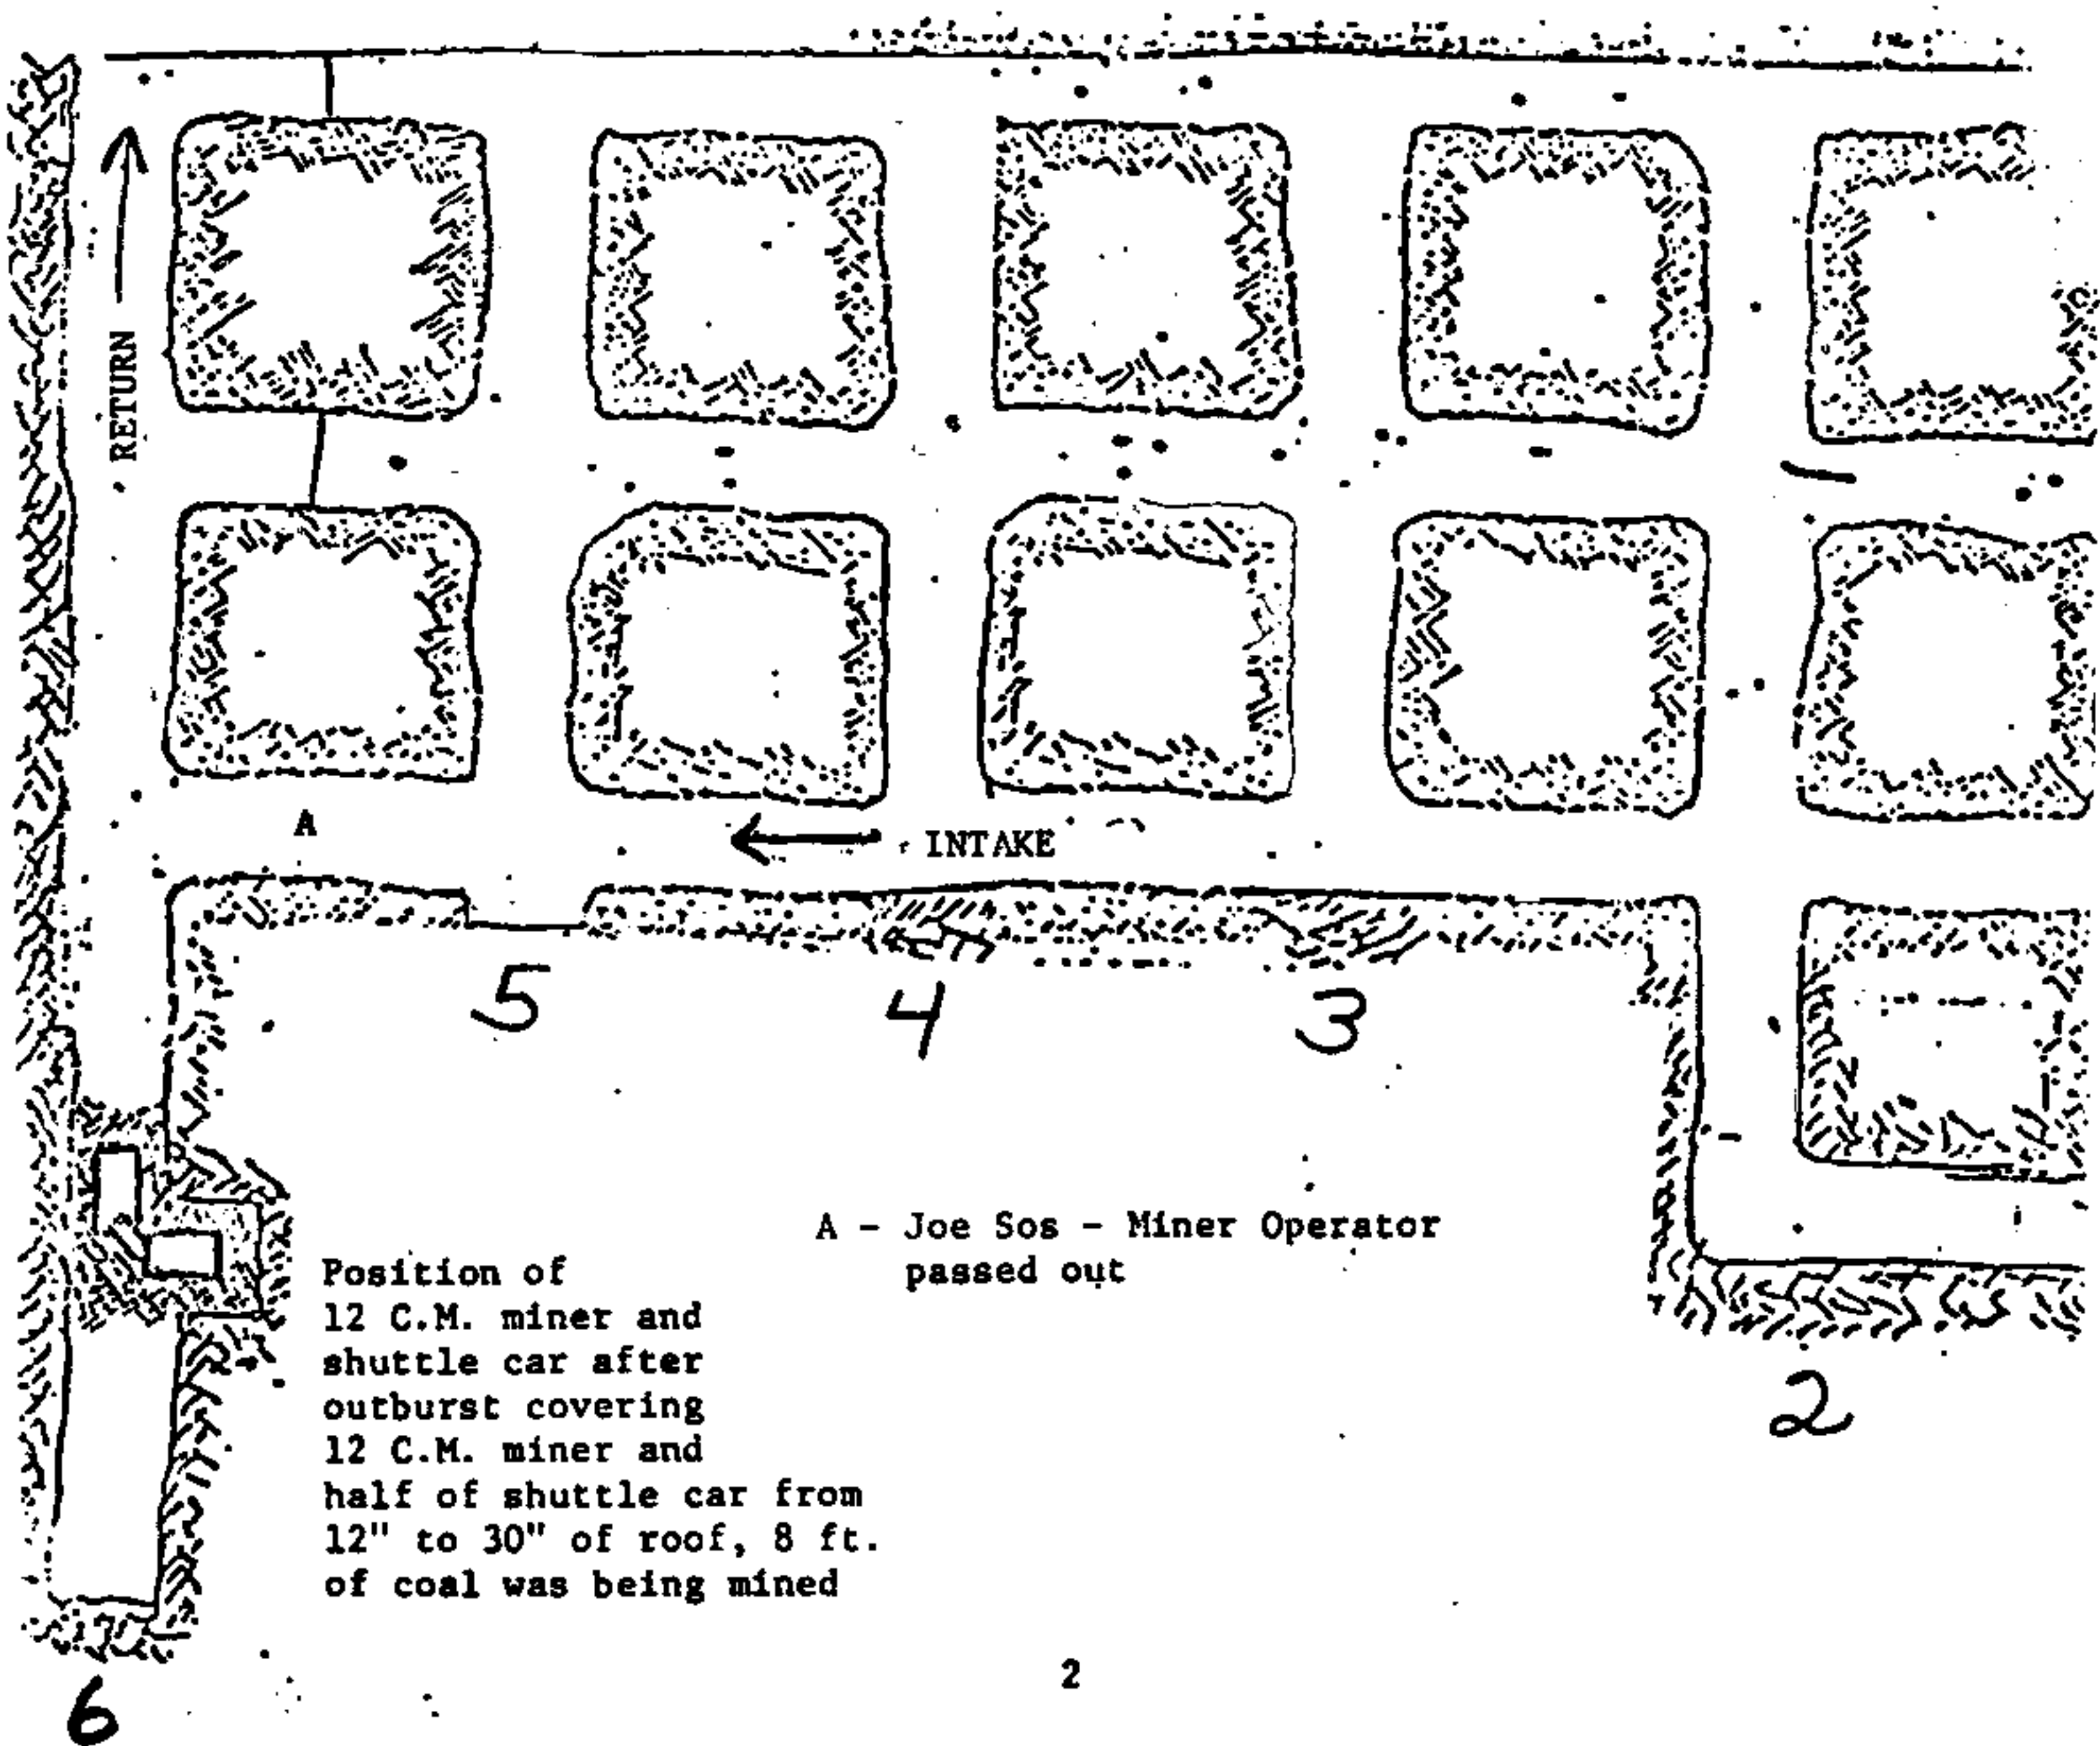
SLOPE SECTION  
001-0

On Monday, June 30, 1980, about 9:15 p.m., an outburst of coal (bounce) occurred in the crosscut being driven from No. 6 slope to No. 5 slope.

1. The force of the outburst coming from the face of the crosscut being mined pushed loose coal about 55 feet outby, filling the entire intersection.
2. The outburst of coal did affect ventilation.
3. This seam of coal has considerable overburden in excess of 2,500 feet.
4. The coal being mined was not being relieved of stress by any means.
5. The equipment was being operated by remote control and the operators were outside of the cabs and located about 70 feet outby the intersection.
